CONSERVATION PLAN

1001 Queen Street West

Issued: September 29, 2014 (revised August 5, 2015)

CAMH Redevelopment Phase 1C

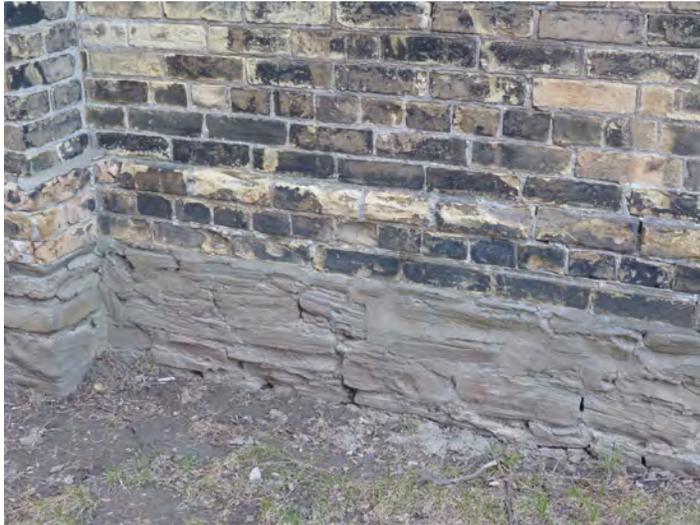
1) **Stone foundation:** Where exposed above grade [between 150 mm (6") and 710mm (28")] the field stone foundation has been parged and repointed using dark, cement-based mortar. There is evidence that this treatment has been reapplied several times to the foundation stones. The parging is failing and delaminating in several areas and some of the stones are loose or have fallen out.

1. Typical cement based parging on stone foundation.

C-29: Remove all cement-based parging and pointing from the full extent of the stone foundation. Reset and/or replace any loose or missing stones. Deep repoint the joints using a soft-lime based mortar. (Note: Additional grouting of core structure may be required for some sections.)

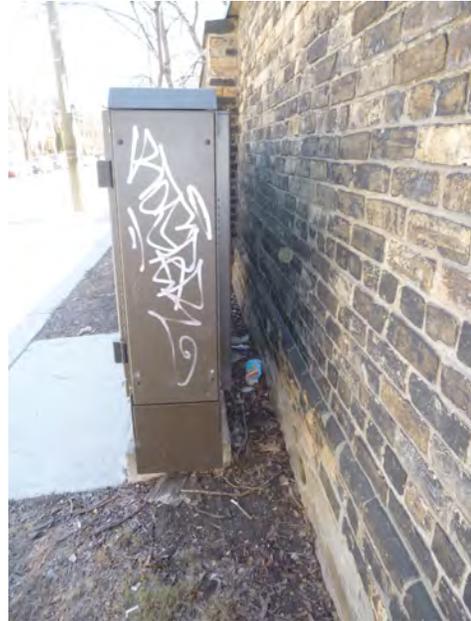
2. Existing service box in close proximity to wall.

C-32: Remove all signs, ferrous metal, fastener and outlets from the wall and repair damage to the brickwork.

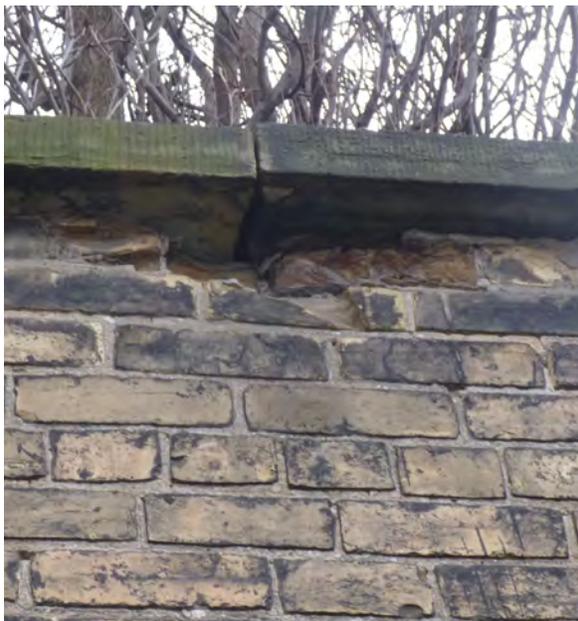
3. Typical deterioration of brickwork under open joints in cap stone.

4) **Stone Cap Mortar Joints:** The mortar joints in stone cap stones have failed. This has resulted in wetting and localized spalling to small areas of brick immediately below the joint.

C-04: Replace localized spalling of brick below existing stone caps. Install metal drip edge flashing on top of wall below caps. Reinstall caps with pin connections and new mortar joints.

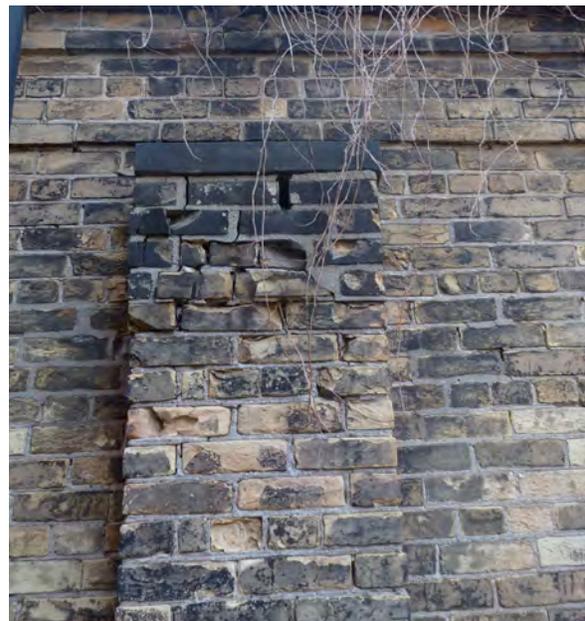
4. Typical deterioration of pier brickwork under stone pier cap due to minimal overhang.

5) **Pier Cap Stones:** The pier cap stones perform poorly. There is minimal overhang and no drip resulting in wetting and spalling of the bricks, and loss of mortar. There have been previous repairs in the majority of the piers. Typically these repairs have been completed using hard, dense replacement bricks and hard cement-based mortar, which is not compatible with the porosity of the original bricks and lime-based mortar. These repairs are stable in some locations, while in other places they have continued to fail and the replacement bricks have spalled, along with more of the original brick units.

C-05: Replace deteriorated bricks and repoint brick joints in piers where damage is minor. Where major damage to brick pier exists, rebuild missing sections of brickwork and fully repoint pier. Install new metal drip edge below pier stone cap and reinstall stone cap, increasing projection drip.

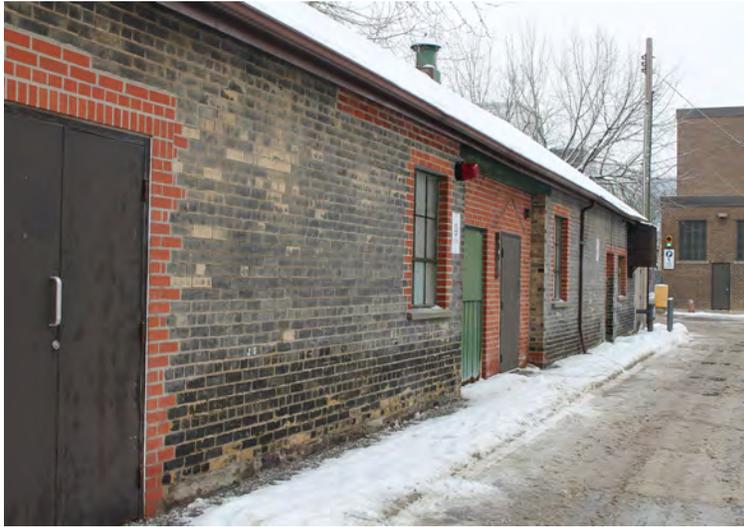
5. View of north elevation of East workshop.

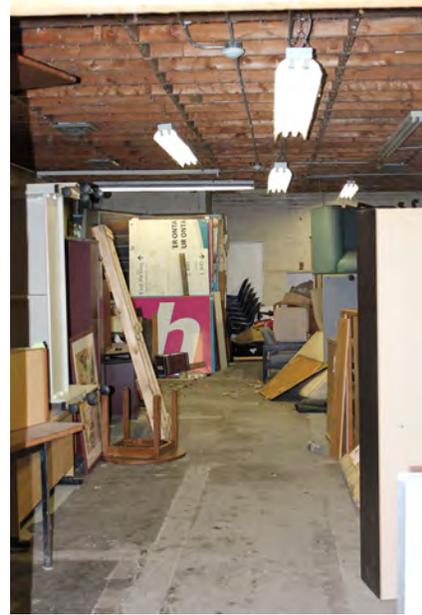
6. View of interior of East Workshop.

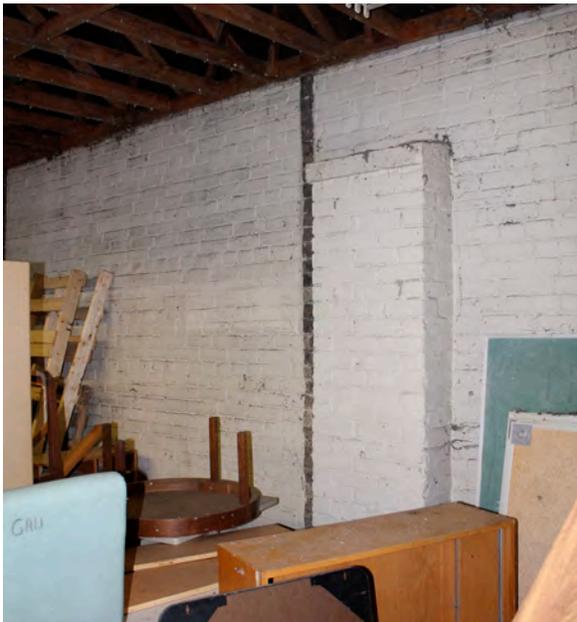
7. View of painted masonry on north side of Segment 6 of Asylum wall on interior of East Workshop.

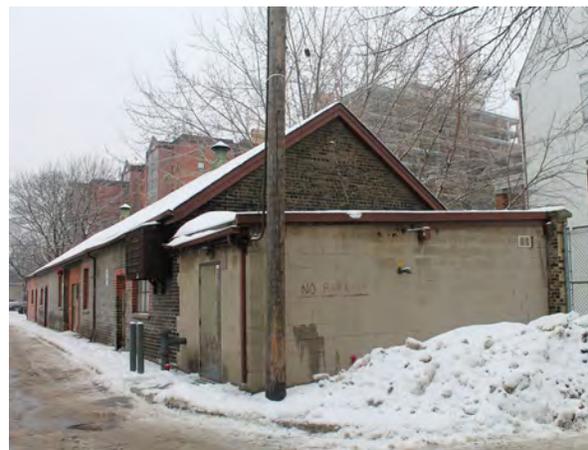
The additions have been constructed using modern, dense, red bricks (east side) and concrete block (west side). The east addition contains washroom facilities that are no longer used and the west addition is a hydro service space. The additions obscure the heritage character of the East Workshop Building and are contributing to the deterioration of the Asylum Wall.

8. View of concrete block addition on west end of East Workshop.

C-06: Carefully demolish the east and west additions, including interior fixtures. The condition of the adjacent Asylum Wall and the East Storage Building elevations will need to be evaluated after the demolition work is complete to determine if additional masonry repairs are required. (Note: Quantities of the red bricks are to be salvaged for the infill repairs described in the Windows & Doors portion of this section).

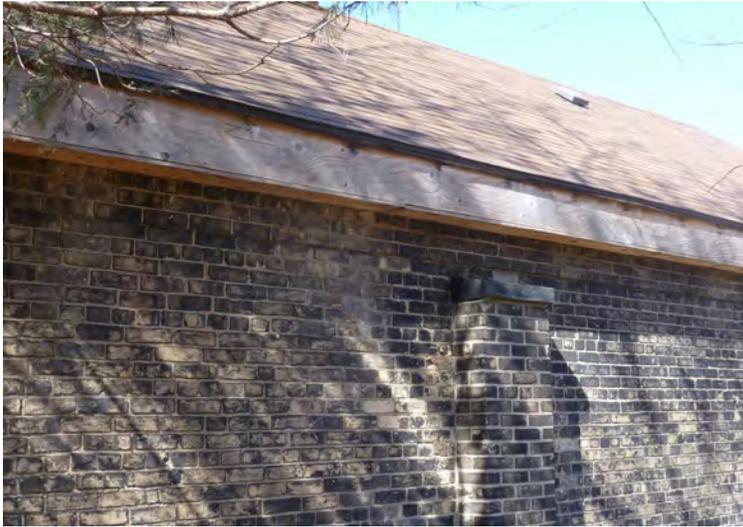
9. Plywood soffit at Segment 6 below East Workshop roof overhang.

C-15: Remove plywood soffit on south elevation and inspect condition of brick and roof edge. Extend roof overhang detail beyond face of piers.

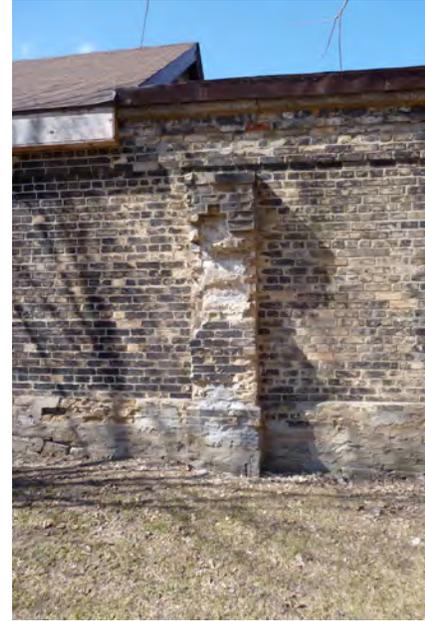
1) Storage Building Adjacency: The lack of overhang on the pier cap stones is particularly problematic on the south face of Segment 6, where there is a considerable amount of water run off from the East Workshop roof, which overhangs the south side of the wall. In the winter months ice tends to build up on the piers at this location leading to prolonged wetting of the masonry. Despite being partially rebuilt the piers in this Segment are heavily deteriorated. The piers have also been rebuilt using hard, dense replacement bricks and hard cement-based mortar, which has accelerated the problem.

10. Deterioration of brick piers at Segment 6 below East Workshop roof overhang where cement cap exists.

C-17: Rebuild missing sections of brickwork and fully repoint pier. Install new metal drip edge below pier stone cap and reinstall stone cap, increasing projection drip.

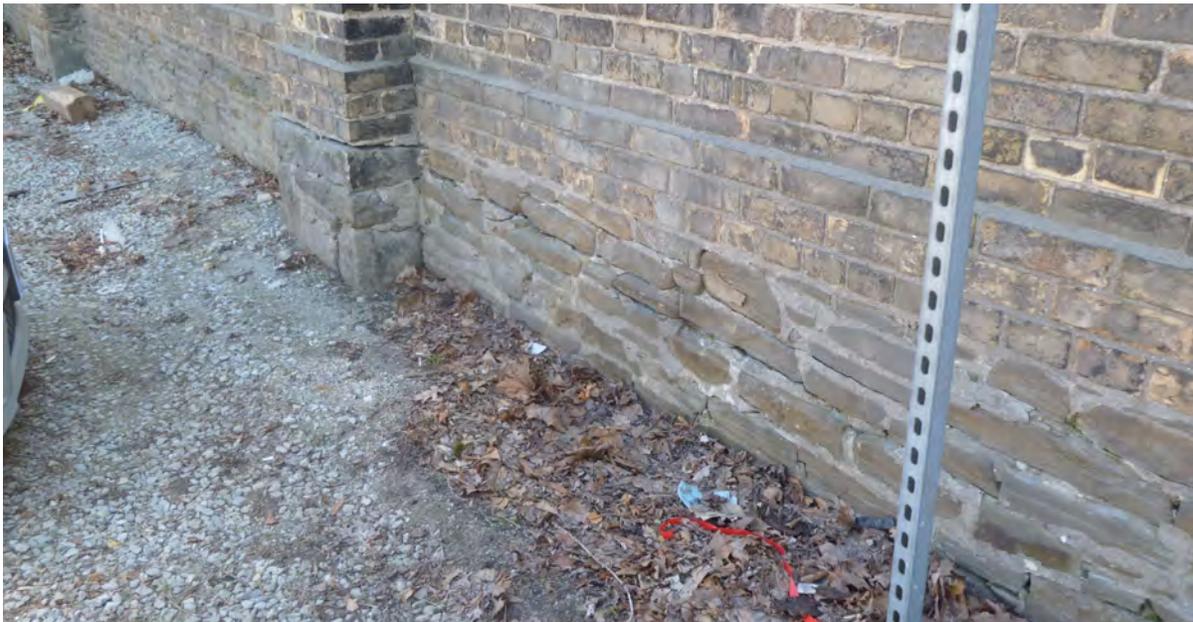
11. Horizontal cracking in foundation joints at Segment 7 (north side).

1) Settlement: There is localized settlement in two bays of the wall resulting in cracking and displacement of the foundation that was initially identified in the 2004 review. The condition was again reviewed in 2007 and at that time there was evidence of movement over the interval. Additional horizontal cracking was noted in the brick joints in the wall above suggesting that the wall is continuing to settle in this location.

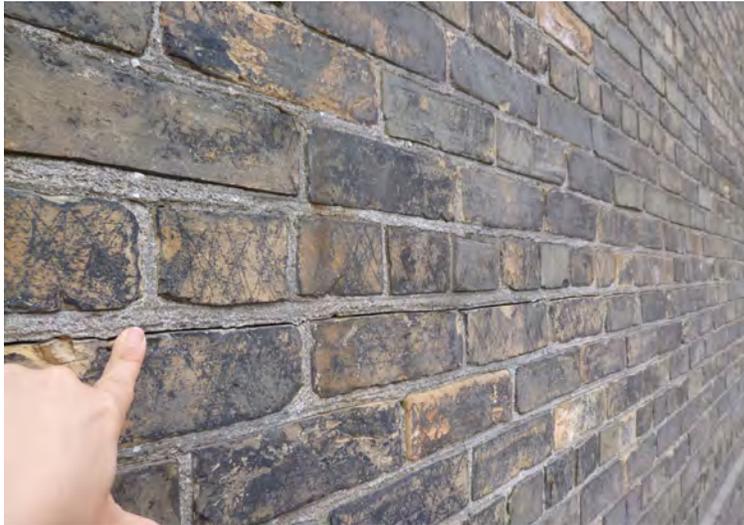
12. Horizontal cracking in brick joints at Segment 7 (north side).

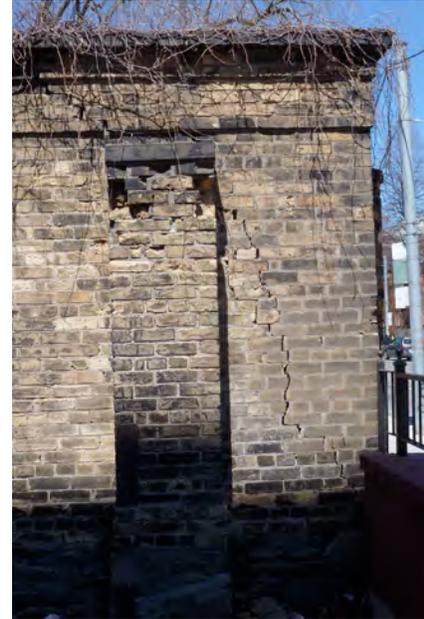
13. Structural cracking at SE corner at Segment 7 and 8.

3) Cracking at SE Corner: At the corner between Segment 7 & 8 there are a number of large cracks that run from the top of the wall down to the base. These cracks extend through the full thickness of the wall.

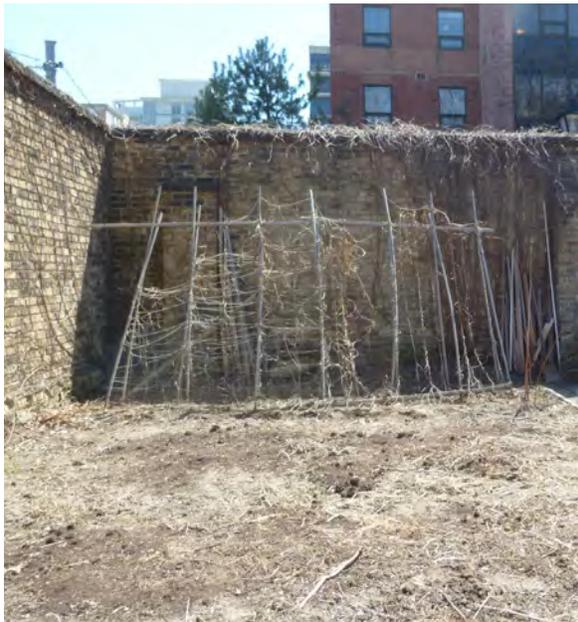
14. Community Garden at Segment 7 and 8 (north side).

4) Community Garden and Vegetation Growth: There is a community garden on the located at the SE corner of the site on the CAMH side of the wall. The soil bed sits high up against the wall and covers the foundation and water table masonry effectively holding moisture against the base of the wall in this area. And because the foundations are generally parged with hard cement on the opposite side of the wall there is no route for this moisture to escape. Vines and other vegetation from the Community Garden are also growing into the cracks that were noted in Item #3 and are contributing to the displacement of the masonry.

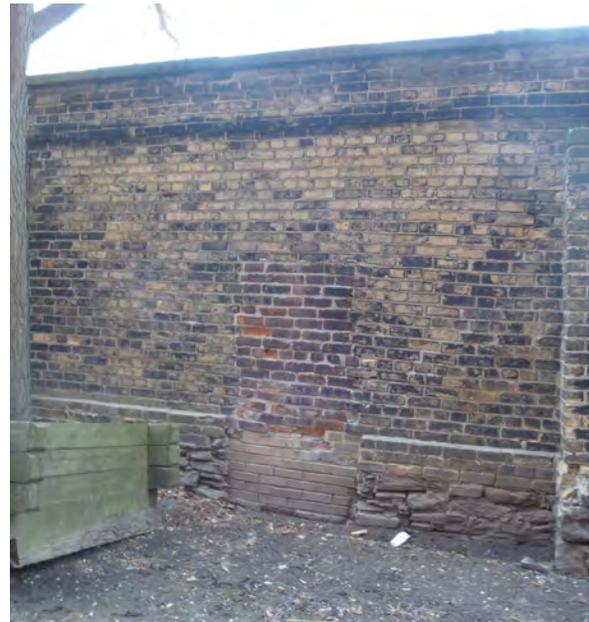
15. Red brick infill at former opening in Segment 7. Note cracking and settlement of brickwork in this area.

same arched detail as the others. The portion of the wall around this opening has settled considerable and there is a noticeable displacement of the brick coursing.

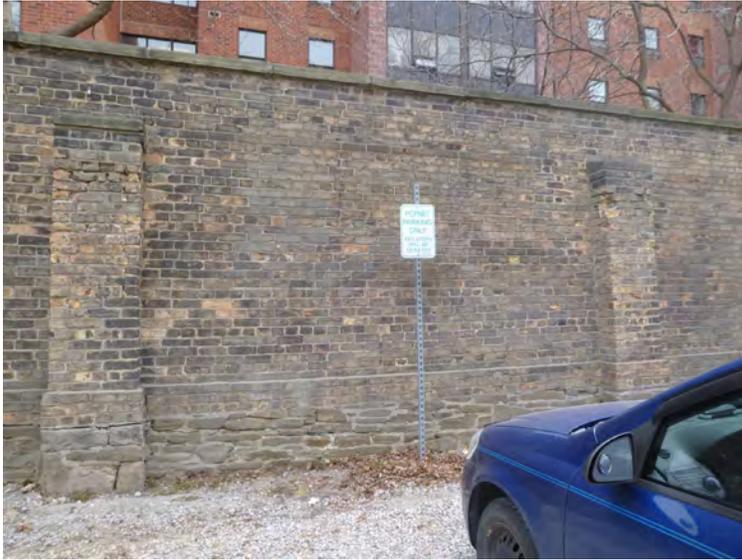
There is also crushed stone paved parking area on the north side of the wall. There are no barriers installed between the parking area and the wall and some of the bricks in the piers have been damaged due to vehicular impact.

16. Parking spaces adjacent Segment 7.

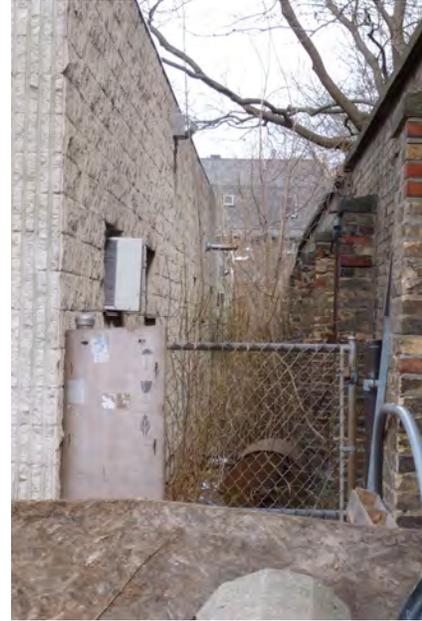
5) Building and Parking Adjacency: There is a Maintenance Building and Greenhouse structure located in close proximity to the wall (within 1 meter). The space between these buildings and the walls was only partially accessible for review. There is debris being stored in this space and around the buildings. There is a lot of moisture damp in this section of the wall which is supporting a considerable amount of vegetation growth from within the masonry.

17. Space between Segment 7 and Maintenance building contains debris and vegetation growth.

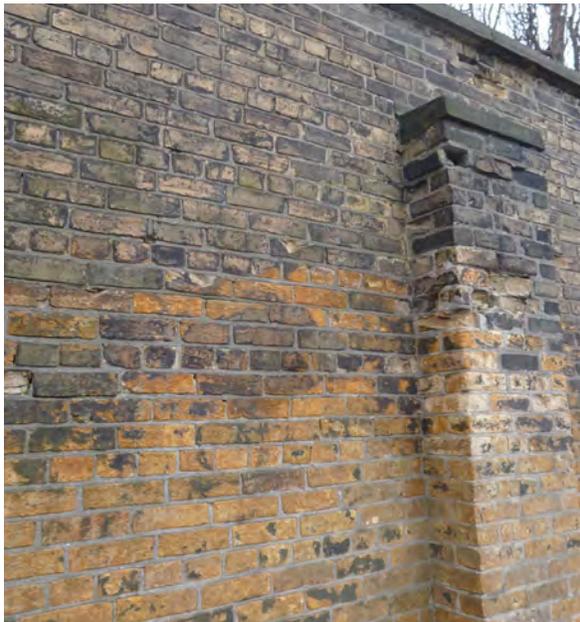
18. Oxide staining on brickwork likely due to historical practice of storing coal against wall.

7) Staining on Brickwork: There is a orange staining pattern on the north side of the wall that runs halfway up the wall and over Bays X-26. This staining is likely the result of historical practice of storing coal up against the wall in this area. There are no repair recommendations for this item.

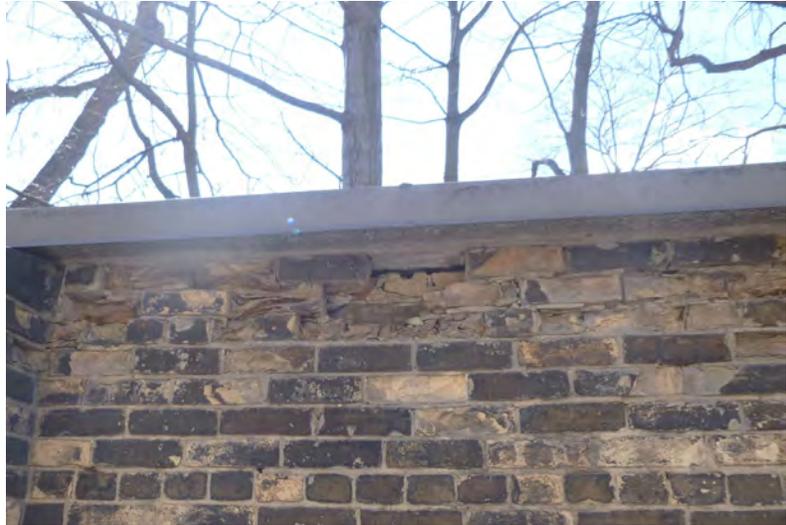
19. Deterioration of brick work underneath cement caps at Segment 11.

C-25: Replace spalled bricks and fully repoint brick courses below cap on both sides of wall. Replace remaining cement caps in Bays 34-42 with salvaged stone caps that have been stockpiled on-site and additional new cap to match existing as required. Install metal drip edge flashing on top of wall below caps. Install caps with pin connections and new mortar joints.

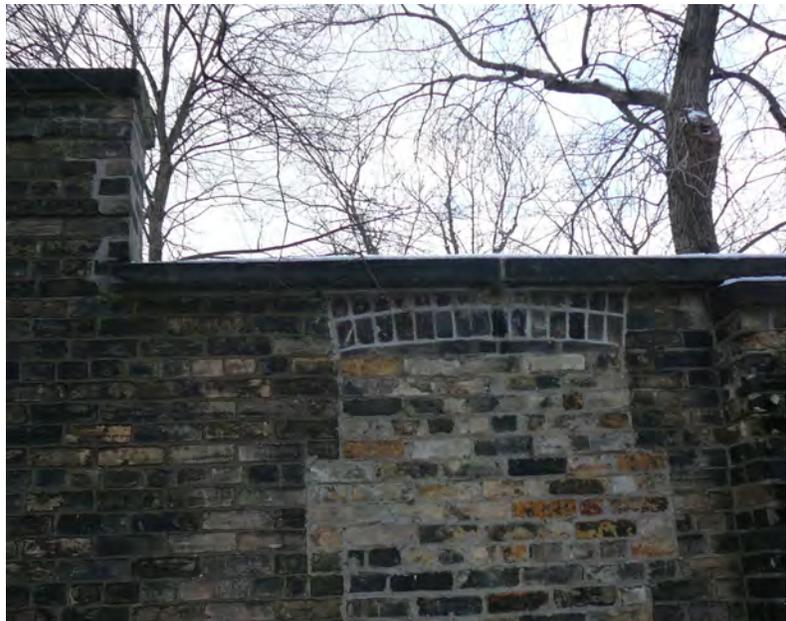
20. Infilled doorway in Segment 11. (Note that wall height has been reduced at this Segment.)

C-26: Restore original height at Bay 32/33 and adjacent pier around the bricked in opening and reinstate opening with repair of arch. Salvage material removed for reuse.

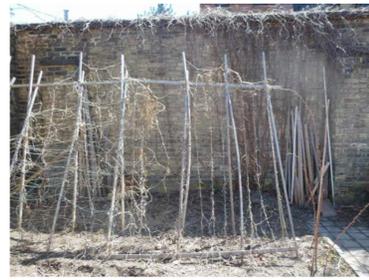
Wall Covered by Vine and Vegetation

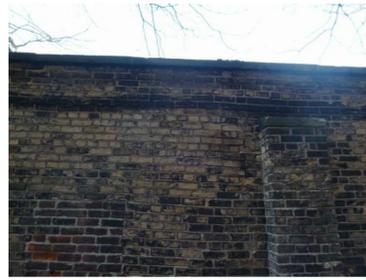
Waive in Brick Coursing Above the Infill Opening

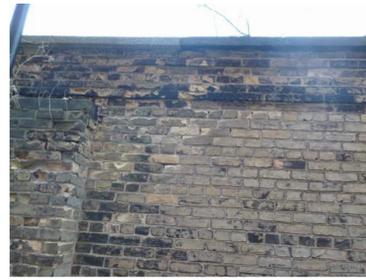
Cement Cap and Deteriorated Masonry Wall

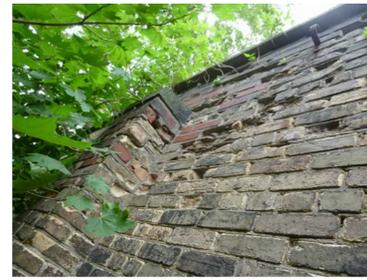
Deteriorated Wall & Pillar - North Side

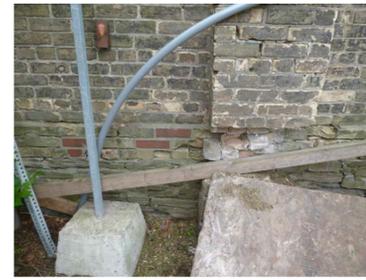
Deteriorated Pier on The North Side

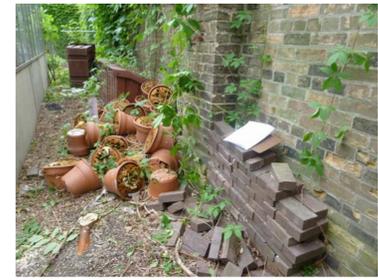
The Wall Covers by Debris - Not Reviewed

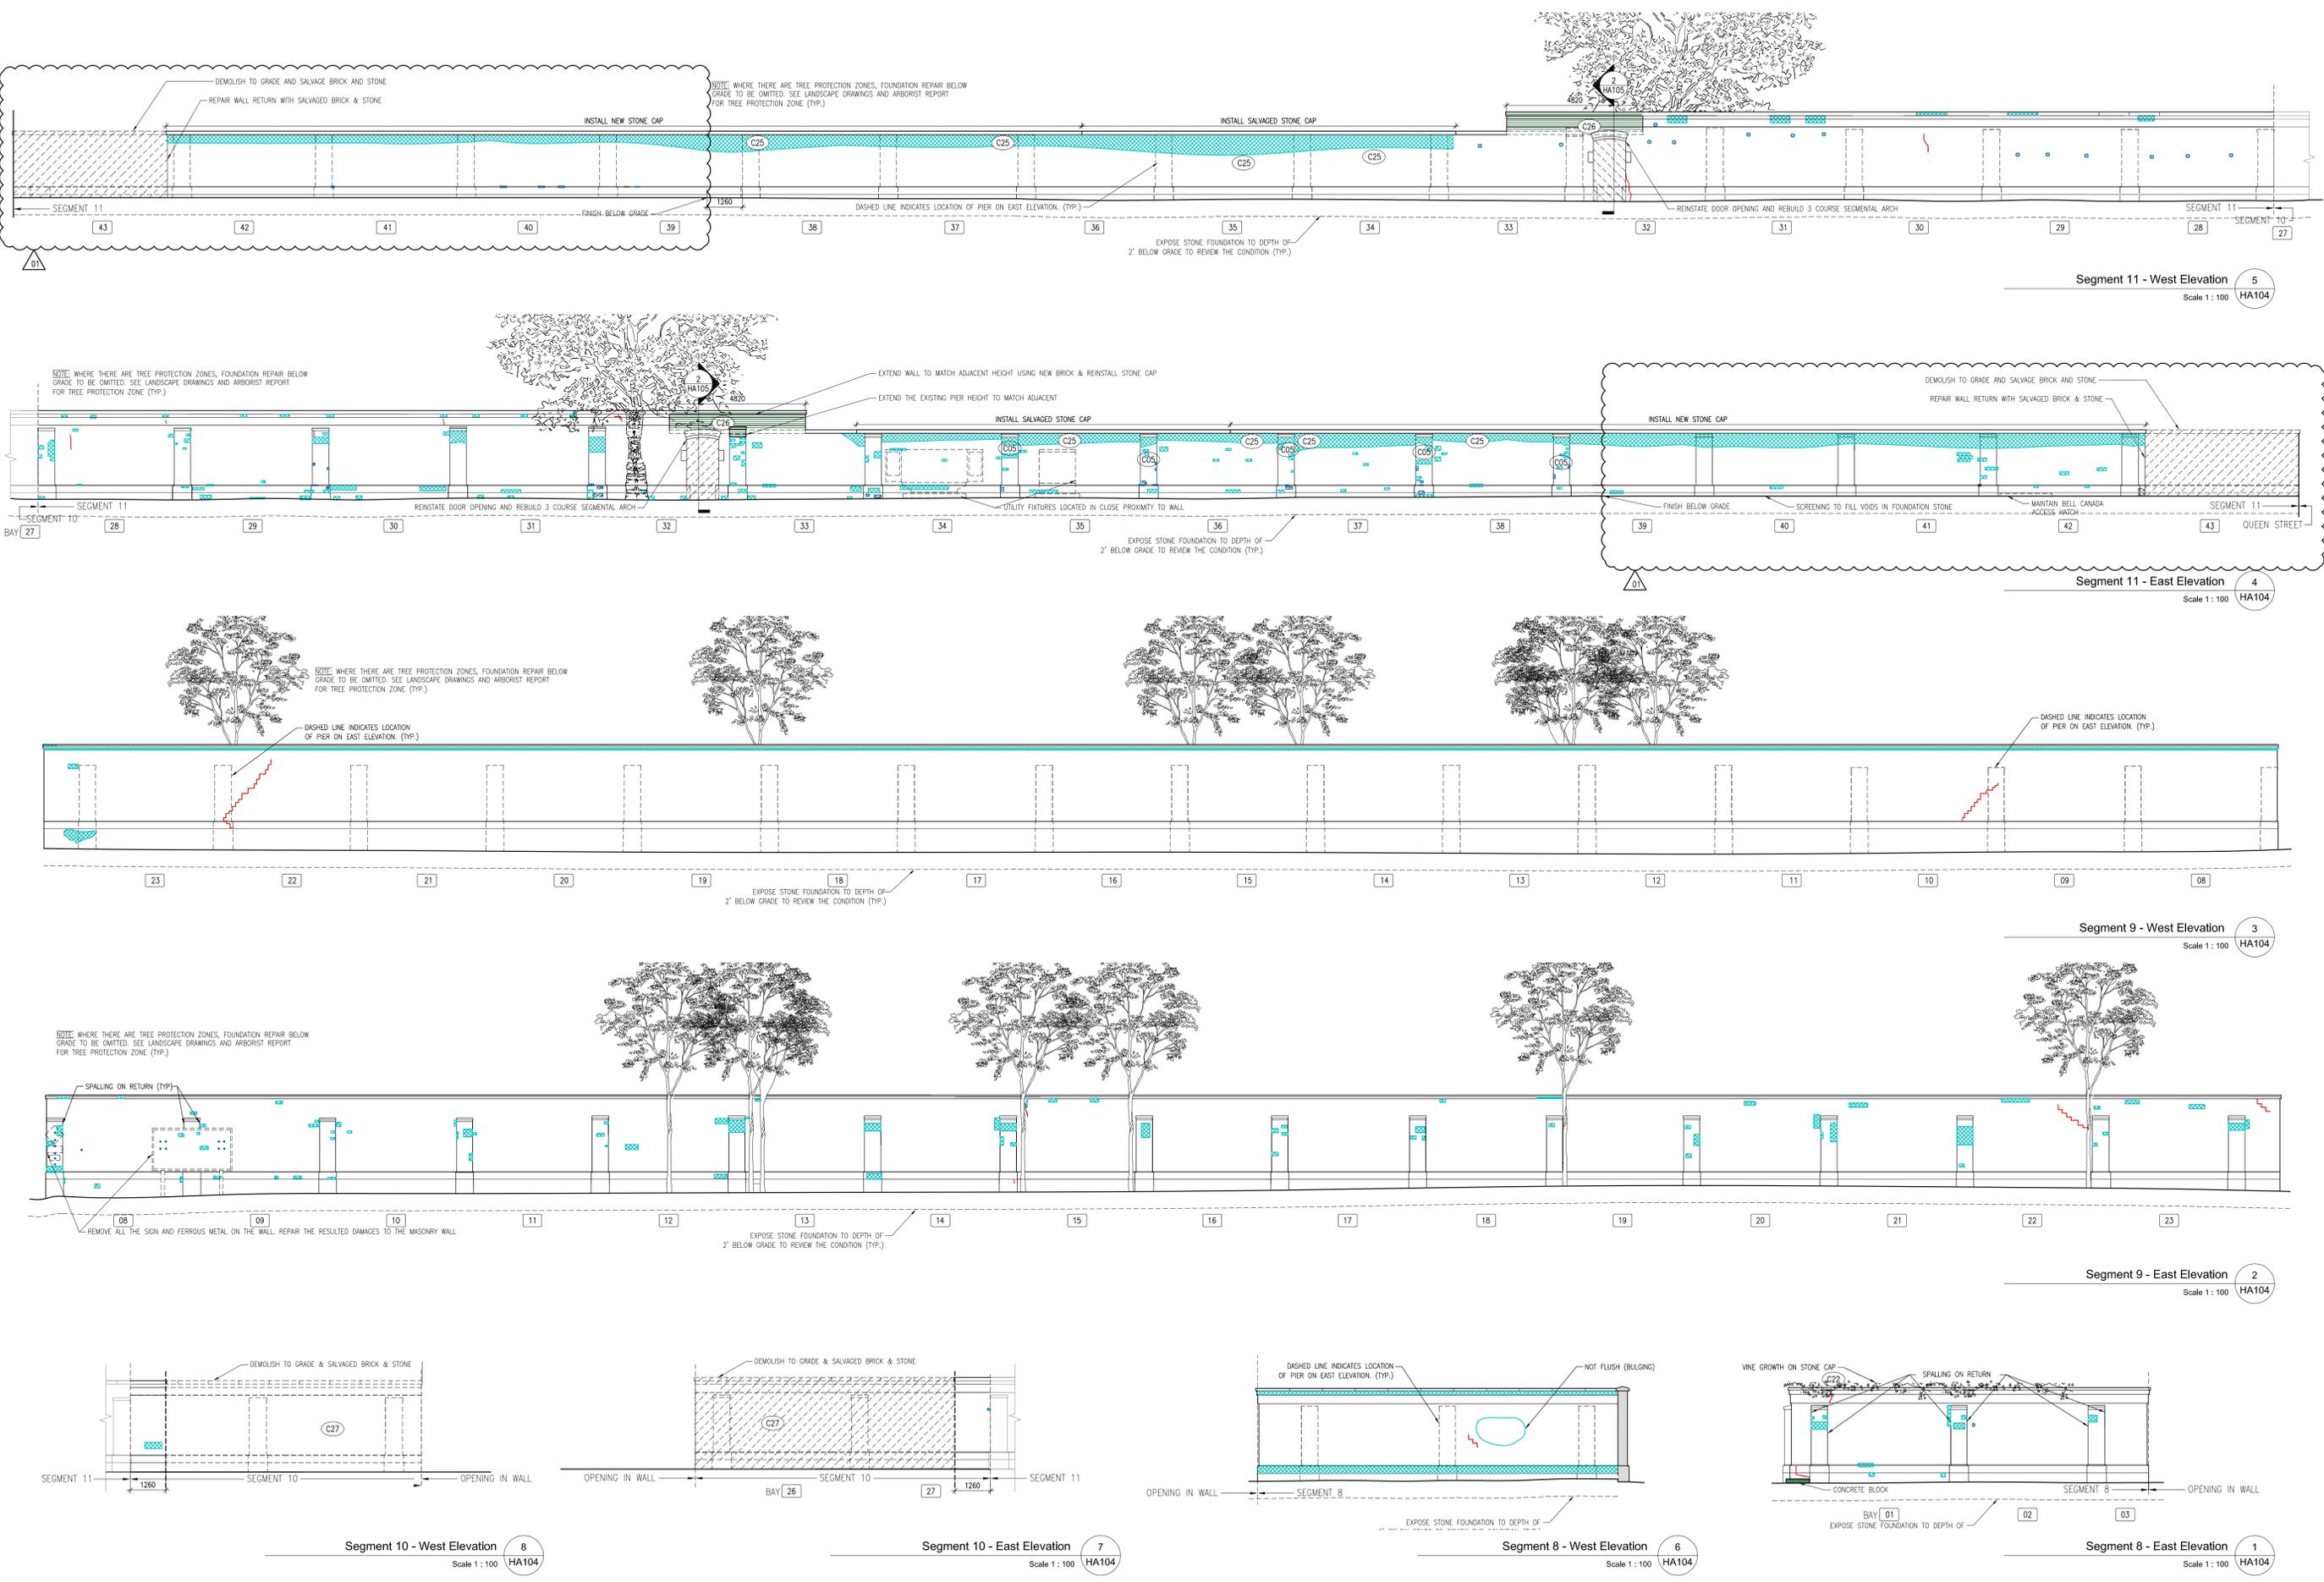
Segment 8, 9, 10 and 11 Conservation Elevations

Adjacent Trees and Services, Snow Pile Up Against the Wall—Refer to 5.2, Conservation Plan:

- C-01: Selectively remove trees and tree roots as identified by Arborist.
- C-02: Reset and/or replace any loose or missing bricks and stones. Deep repoint the joints using a soft-lime based mortar. Provide mortar fillet to top of water table where sloped bricks are missing to ensure positive drainage.

- C-31: Excavate to 2'-0" below final grade at all accessible locations of the wall. Clean, deep repoint and grout if voids are encountered. Parge smooth to grade and install drainage layer prior to back fill.

- C-32: Remove all signs, ferrous metal, fastener and outlets from the wall and repair damage to the brickwork.
